MIRADOR PROJECT

Bridge Review from Site to Puerto Bolivar, Ecuador

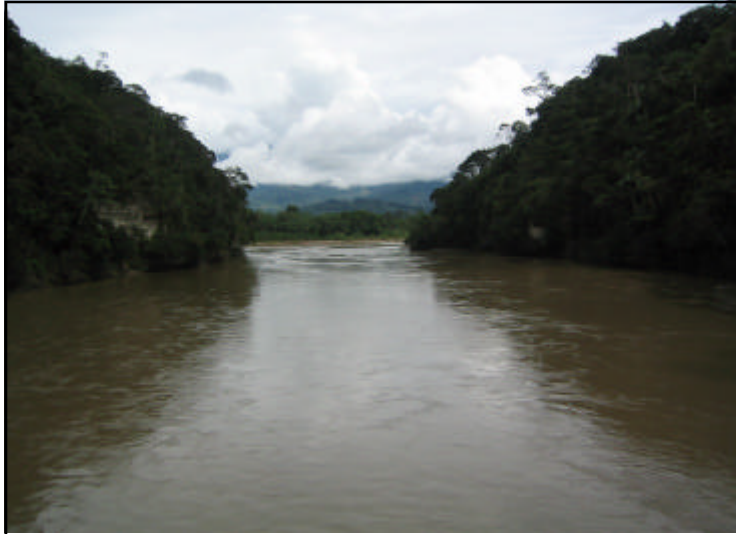
Picture Title: BR01.jpg

The road from the site to the Zamora River, and then from the river to the junction with the Amazon Highway is approximately 6.5m in total. The road is relatively narrow and will need some upgrading to get to 6m wide, with a few minor slide areas to be managed. See the last photo in this report showing the road to the river from site.

The review of alternative river crossings has confirmed that a 155 m long span will be needed. It will be a 6m wide, timber and steel composite deck spanning the river to rest on piled concrete abutments on either side, although there is the suggestion that there is a rock outcrop on one side that will help reduce the span. Currently there is a ferry that crosses some 300m upstream from the proposed crossing but it will not be adequate for the construction period or the operating period when concentrate and supply trucks will need to cross the river.

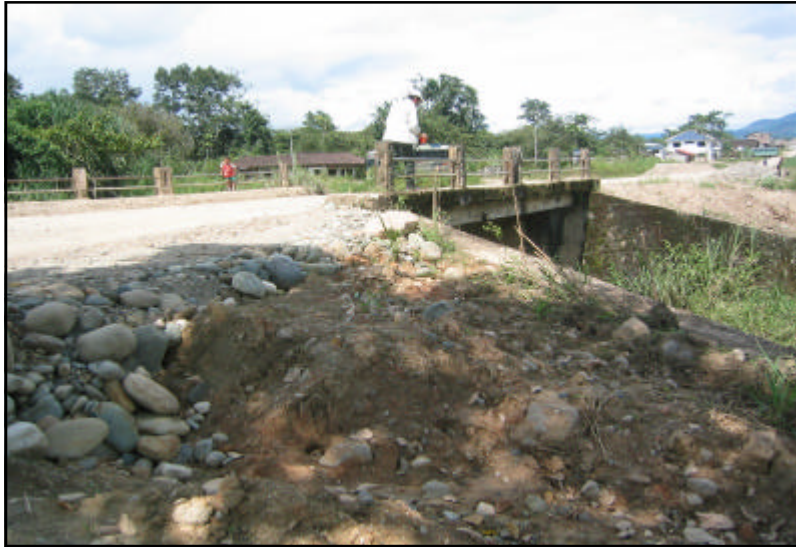
Picture Title: BR03.jpg

This is the first bridge crossing on the Amazon Highway heading towards Loja and on to the coast.

Construction is typical of most of the small bridges on route. The style is a concrete box with wing walls on both up and down stream locations, a concrete kicker on each side of the travel width and about 6m wide, and 8m long. The bridge is in good condition for the traffic intended.

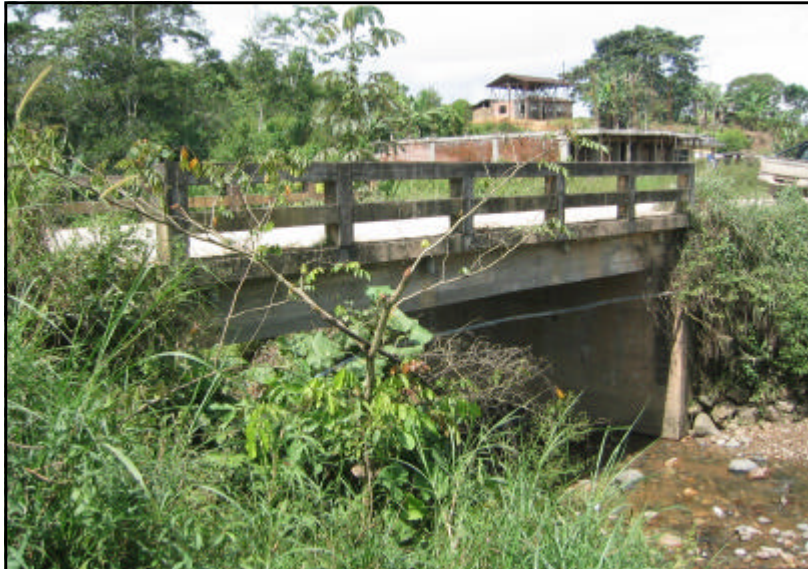
Picture Title: BR04.jpg

After the small town of El Pangui, the second bridge on the highway is the same as the previous, and in good condition for the traffic intended.

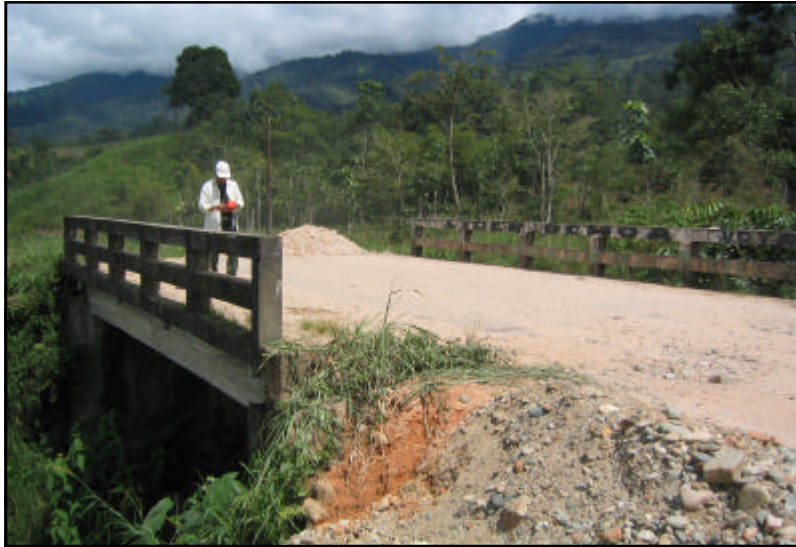
Picture Title: BR05.jpg

Same as previous, but with no kickers. Rails are typically concrete or concrete and steel rail.

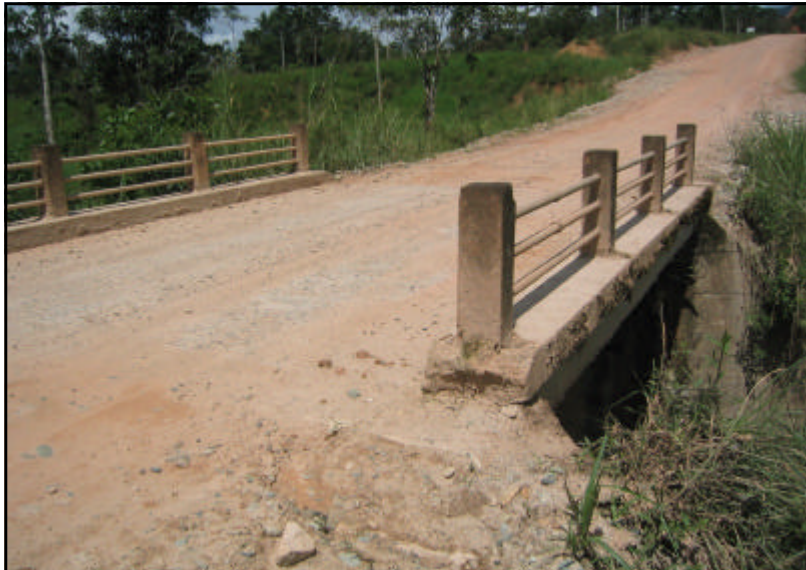
Picture Title: BR06.jpg

Same as previous except with concrete kickers.

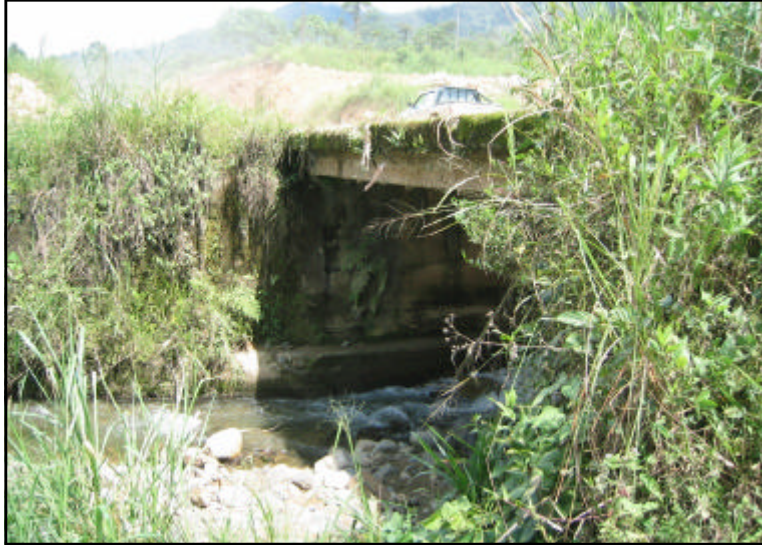
Picture Title: BR07.jpg

Concrete box section with wingwalls, but no handrails or kickers. This one is a narrower 5m wide running surface. There may be a need to install some concrete no post rails on either side for safety.

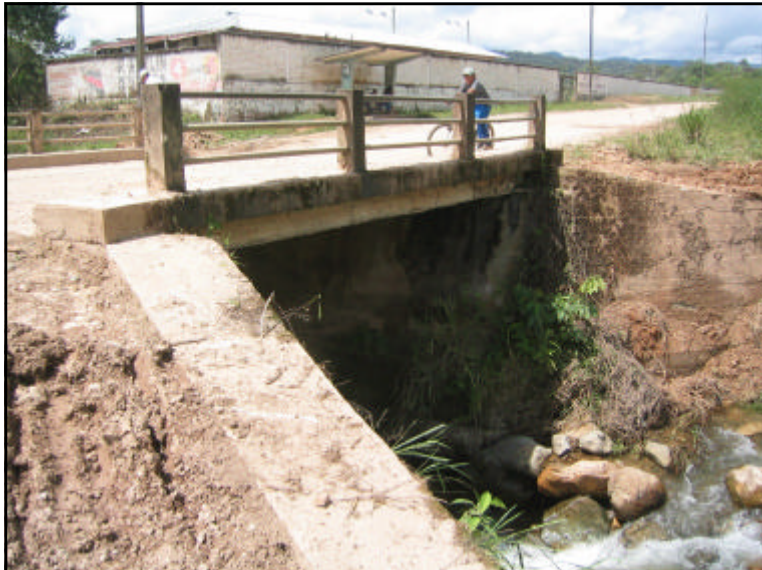
Picture Title: BR08.jpg

Typical bridge section the same as BR06.

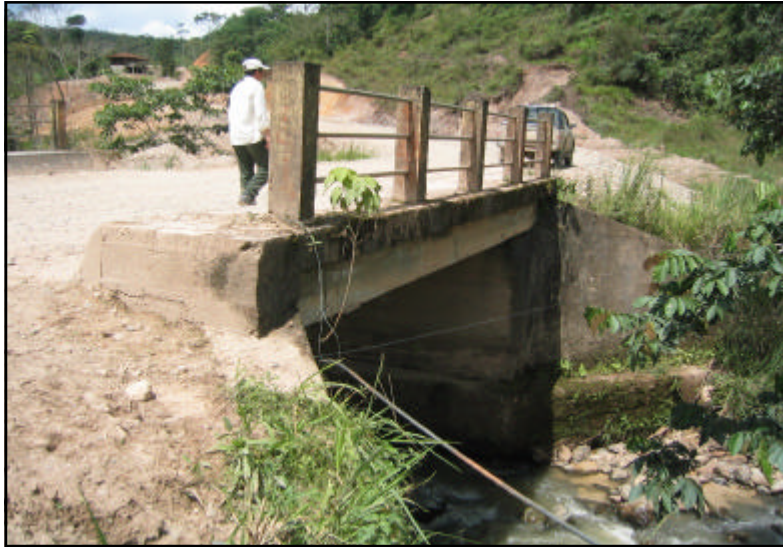
Picture Title: BR09.jpg

Same as BR06. Some grading and ditching to do as the road rises away to the west - but very easy work and likely performed by government agency responsible.

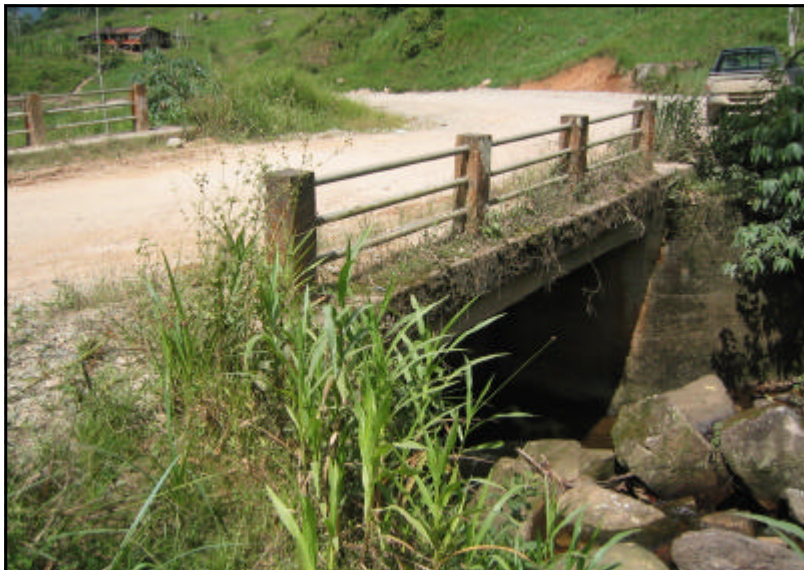
Picture Title: BR10.jpg

Good construction similar to BR06.

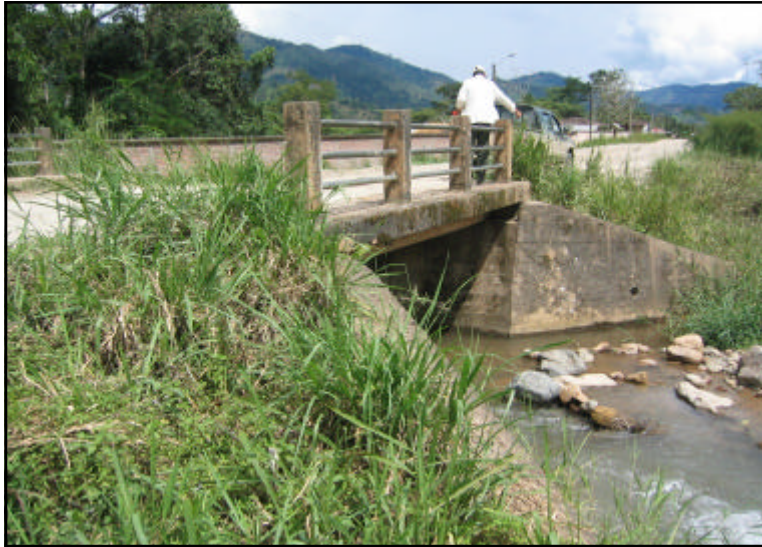
Picture Title: BR11.jpg

Same as BR06.

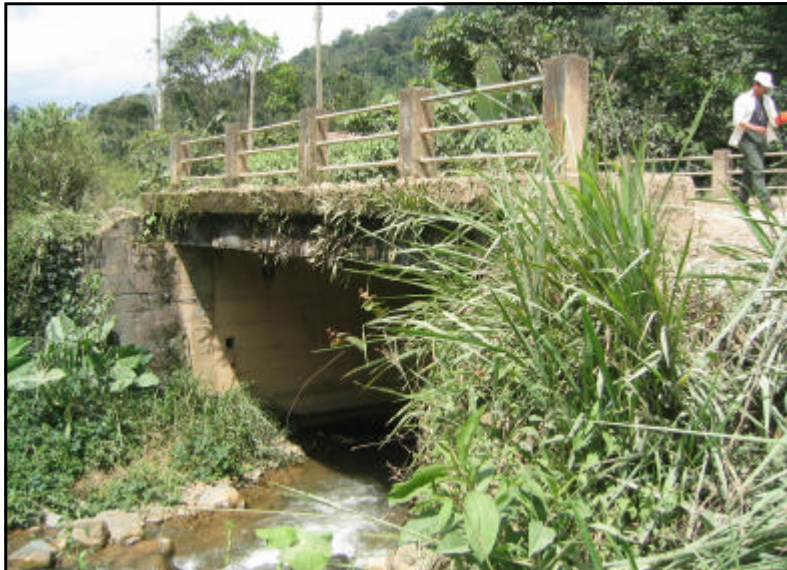
Picture Title: BR12.jpg

Same as BR06

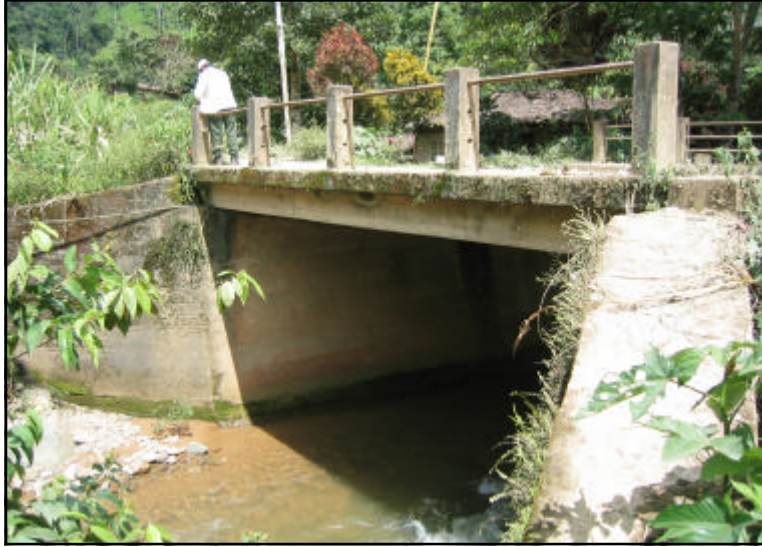
Picture Title: BR13.jpg

Same as BR06.

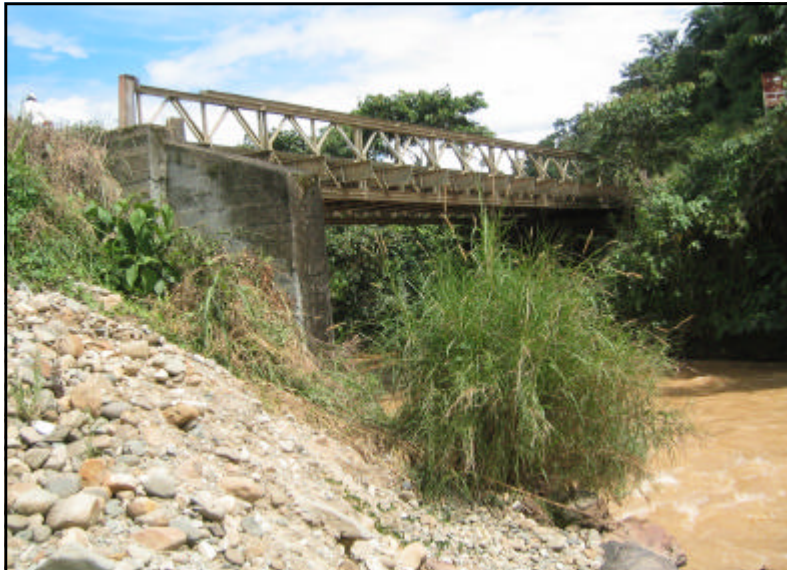
Picture Title: BR14.jpg

This bridge is being replaced by the local government authority. The new steel bridge sections had arrived and were sitting on the east side.

The span is about 15m long and of steel construction with concrete abutments and wing walls in good condition.

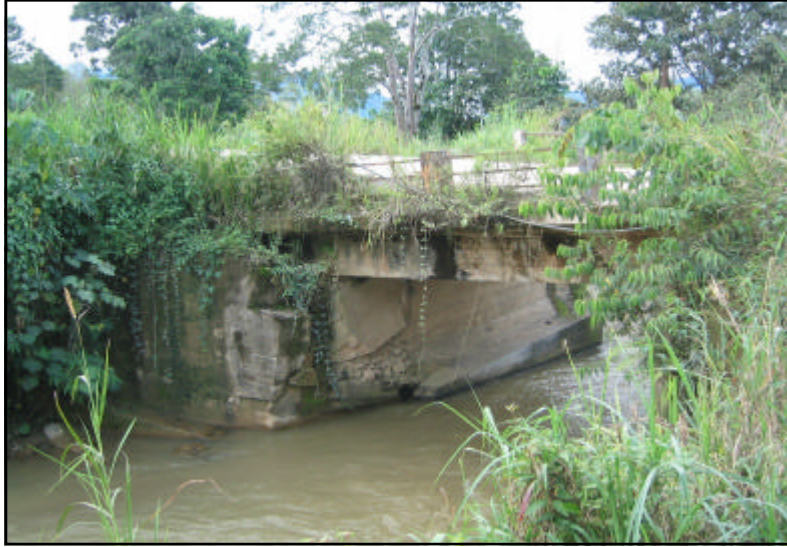
Picture Title: BR15.jpg

Same as BR06.

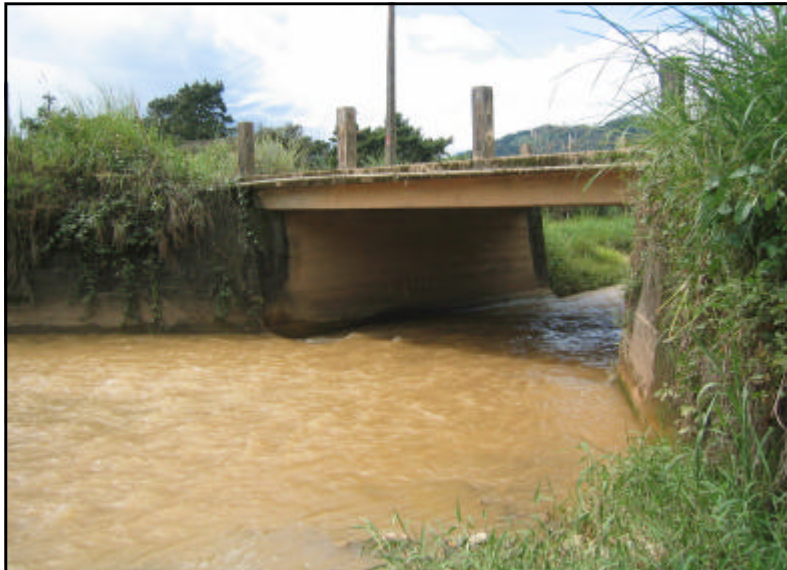
Picture Title: BR16.jpg

Same as BR06 except that the handrails have been removed and should be replaced.

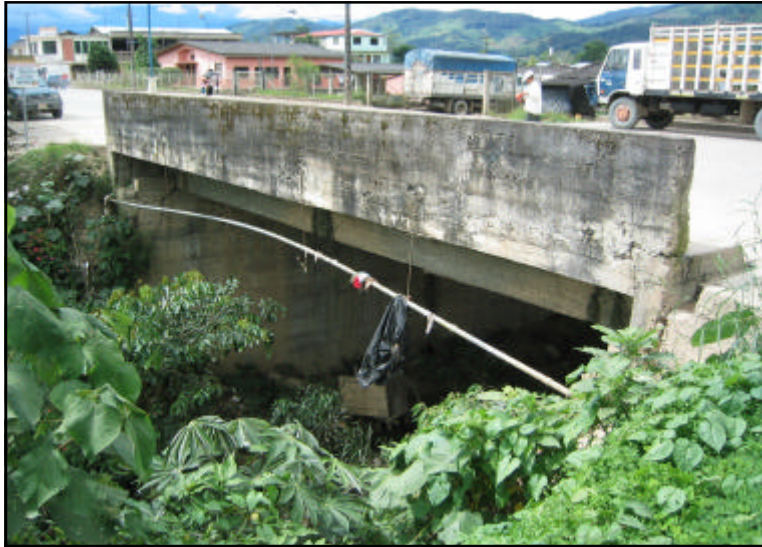
Picture Title: BR17.jpg

This concrete bridge is in the town of Yantzanza. It has a running width of about 10m and has concrete side walls and is in good condition.

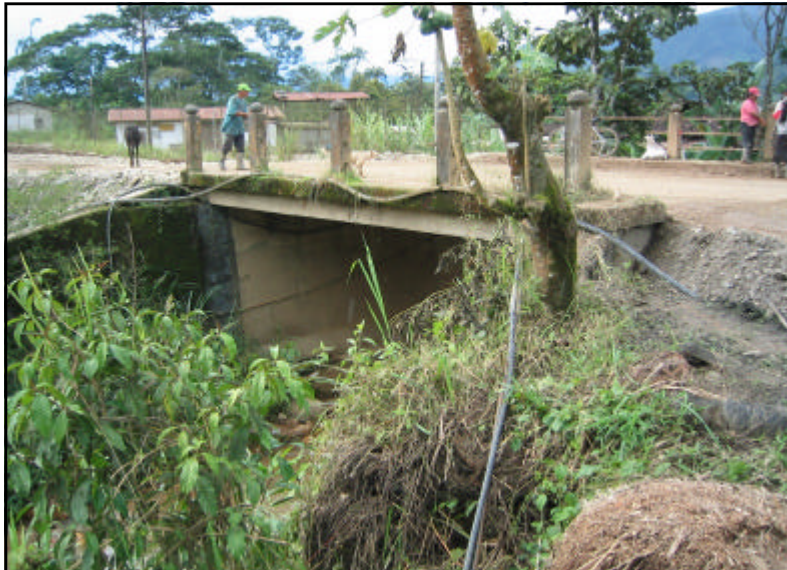
Picture Title: BR18.jpg

Same as BR06 but some handrailing needs to be replaced.

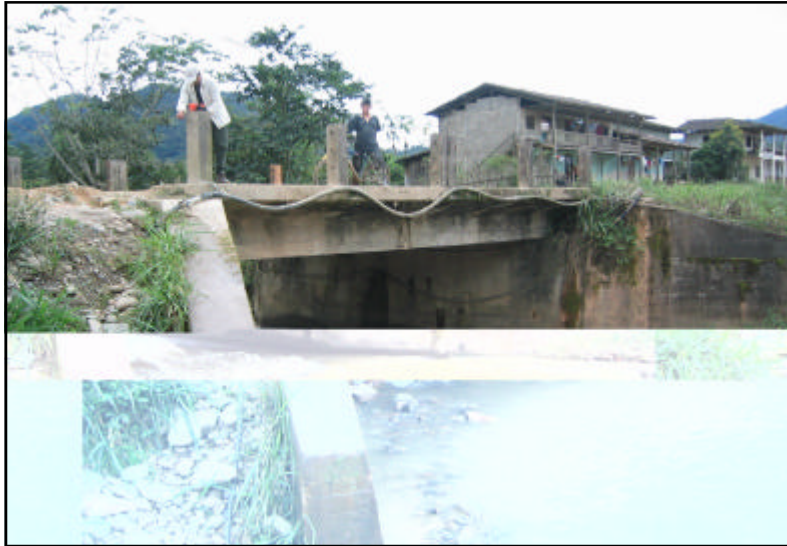
Picture Title: BR19.jpg

Same as BR06 but with hand railing to be replaced.

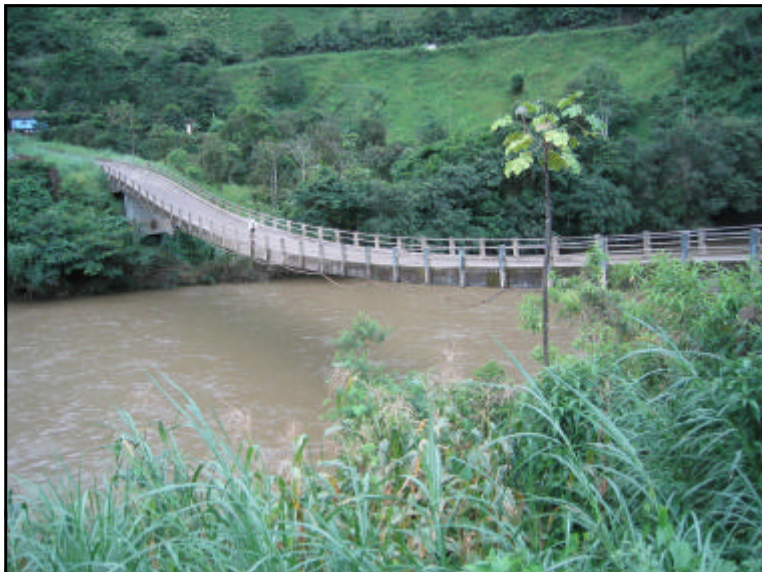
Picture Title: BR20.jpg

This bridge is to be replaced by the federal government out of Quito. It has a capacity of 40T and the local quartz trucks have to be broken down to cross. The bridge comprises pre-cast concrete beams, and a concrete deck with side rails and a running width of about 10m.

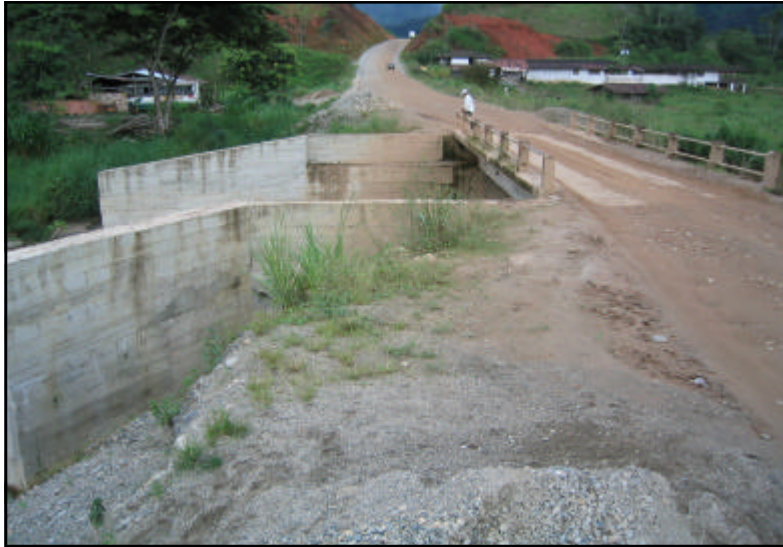
Picture Title: BR21.jpg

All concrete with a 40ft long travel width of about 10m and in good shape.

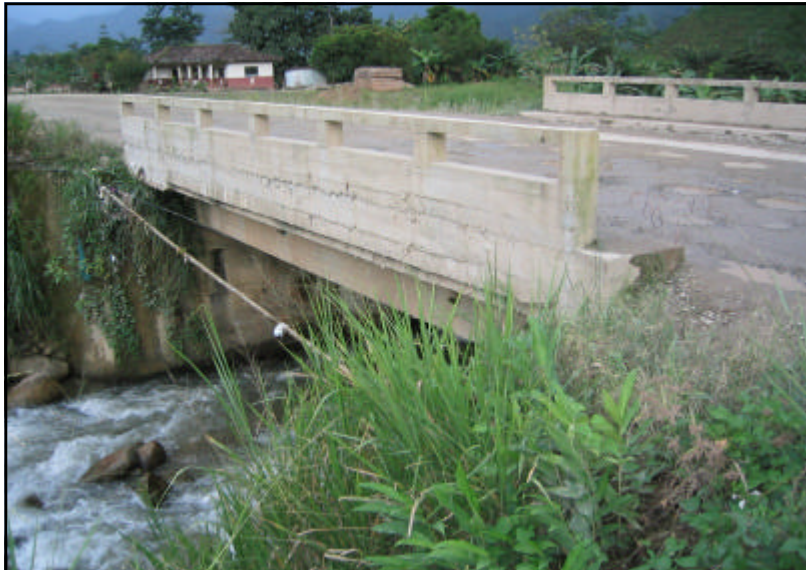
Picture Title: BR22.jpg

Similar to BR21 with a travel width of nearly 10m.

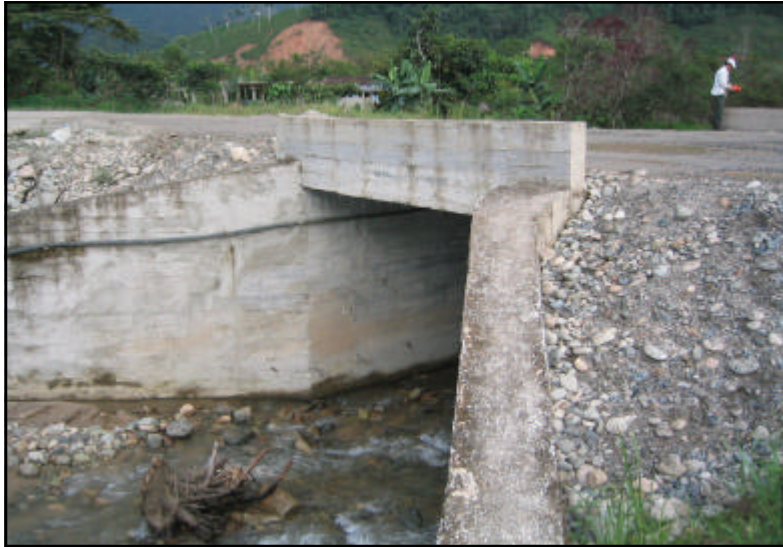
Picture Title: BR23.jpg

Similar to BR22.

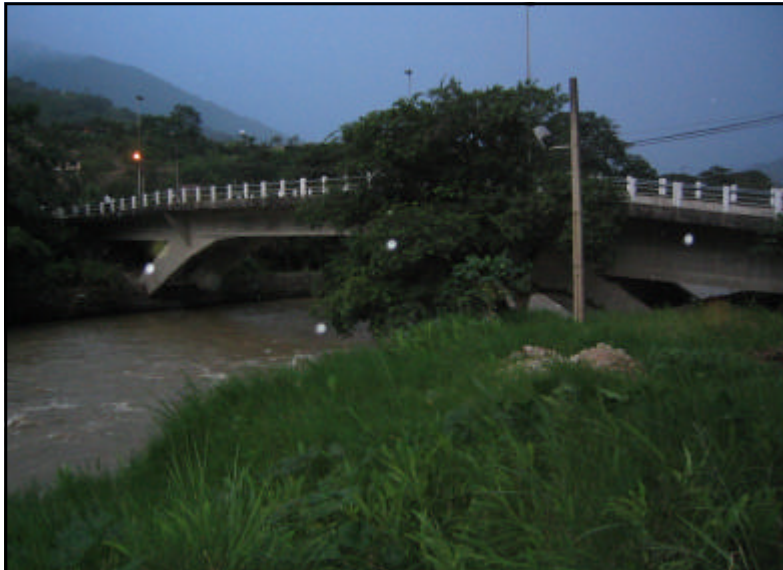
Picture Title: BR24.jpg

The gravel road ends here at Zamora and travels through a relatively residential area to the next bridge. This one is in good shape, made of concrete, has a 10m wide travel width complete with railings and sidewalks.

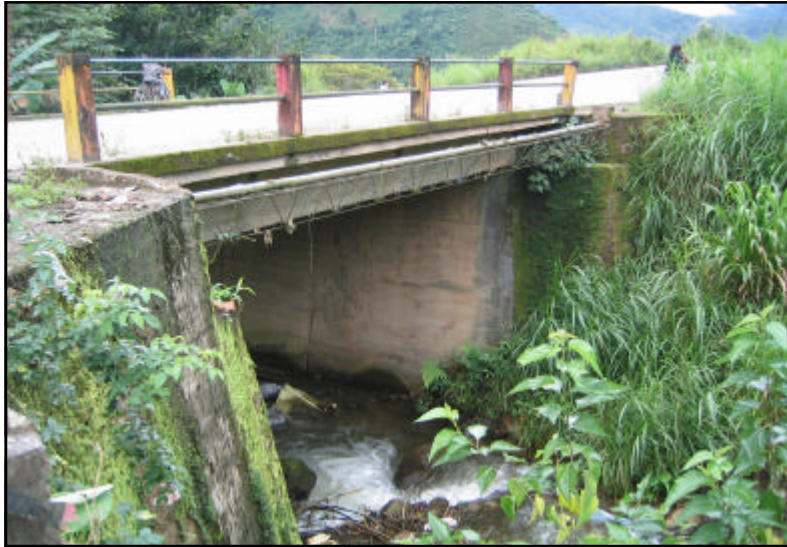
Picture Title: BR25.jpg

Same as BR06 except this is an asphalt road.

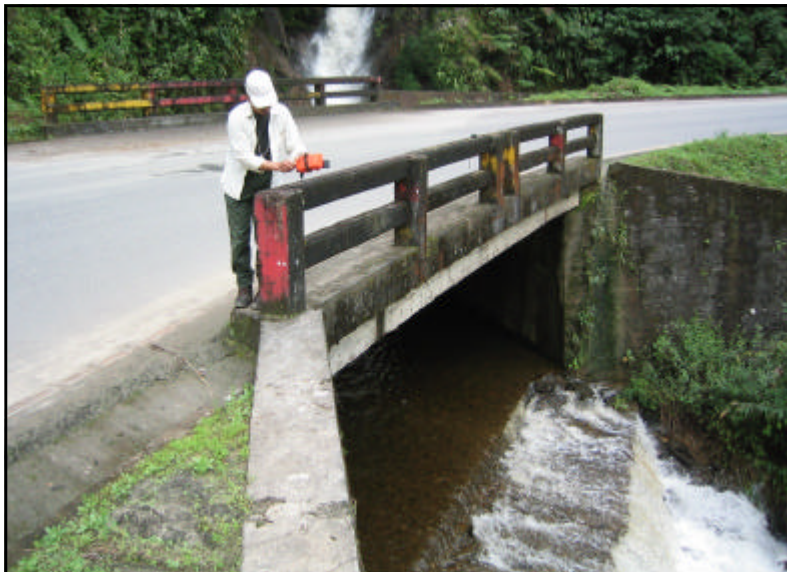
Picture Title: BR26.jpg

Same as BR25.

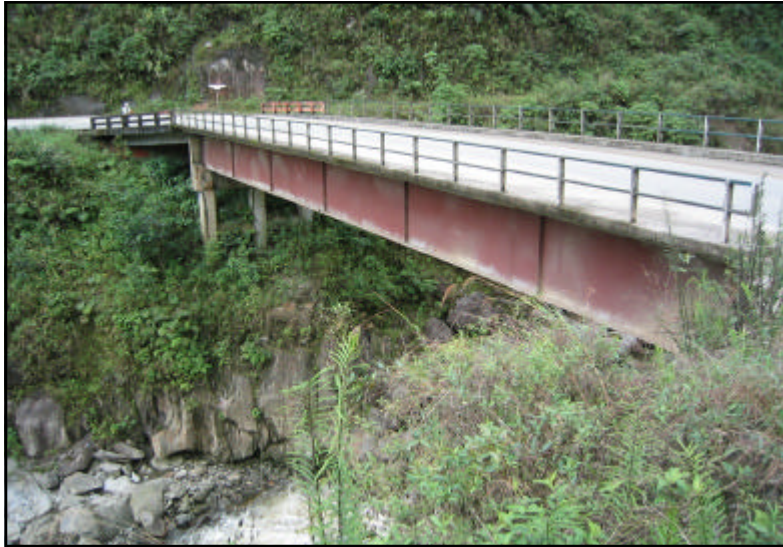
Picture Title: BR27.jpg

This is a steel girder bridge, with a 10m wide travel width and in good condition.

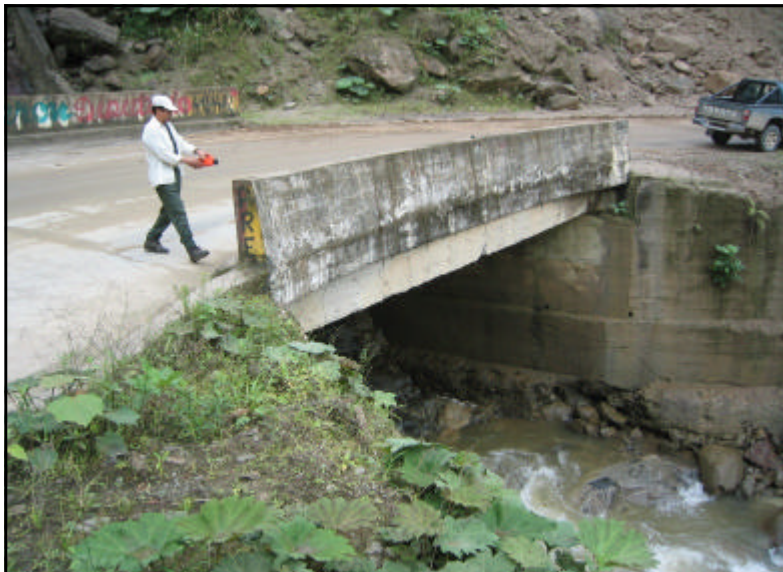
Picture Title: BR28.jpg

Good condition bridge similar to BR21 except with a concrete wall side rail.

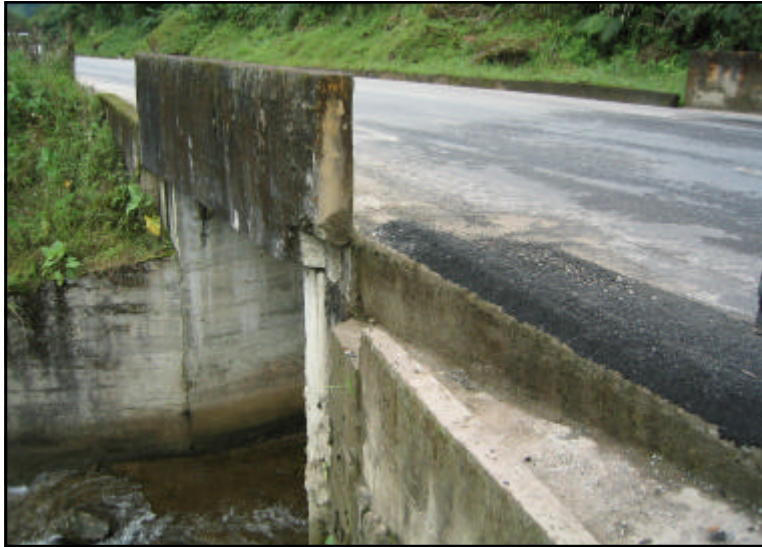
Picture Title: BR29.jpg

Same as BR21 except with a waterfall on the upstream end.

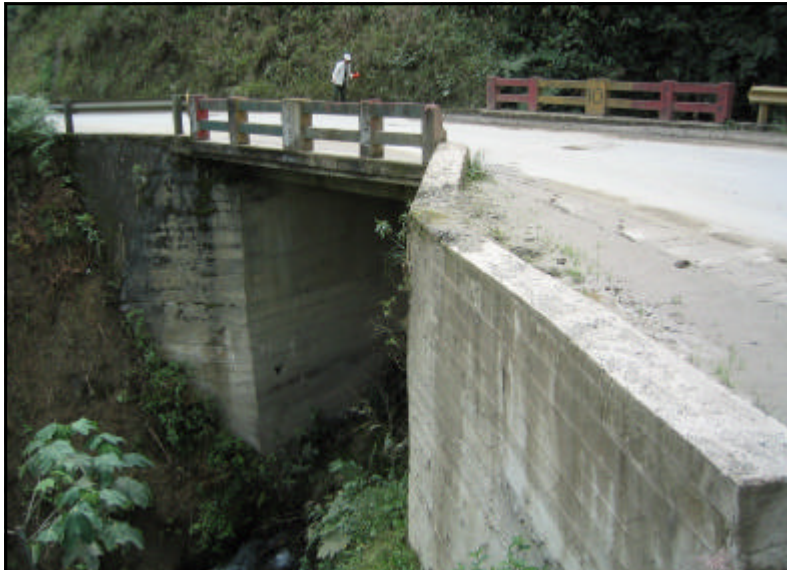
Picture Title: BR30.jpg

The road leading to this bridge is in the valley with some side slopes needing stabilization. The bridge is similar to BR21.

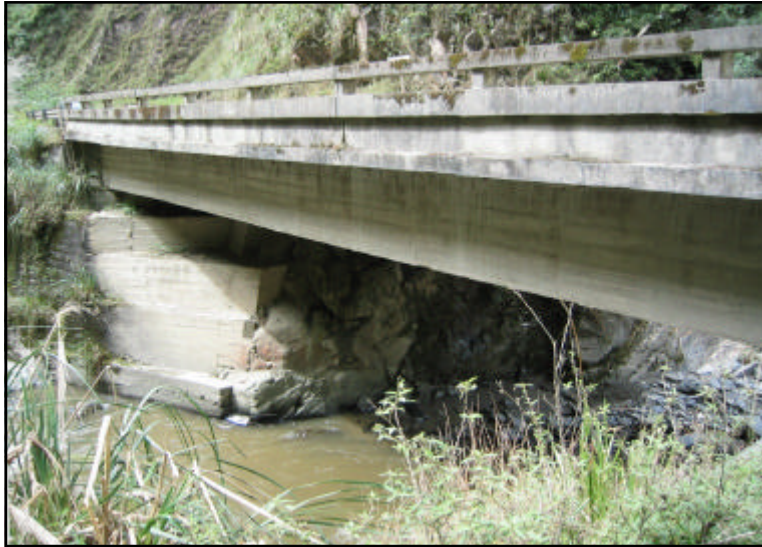
Picture Title: BR32.jpg

Similar to BR21

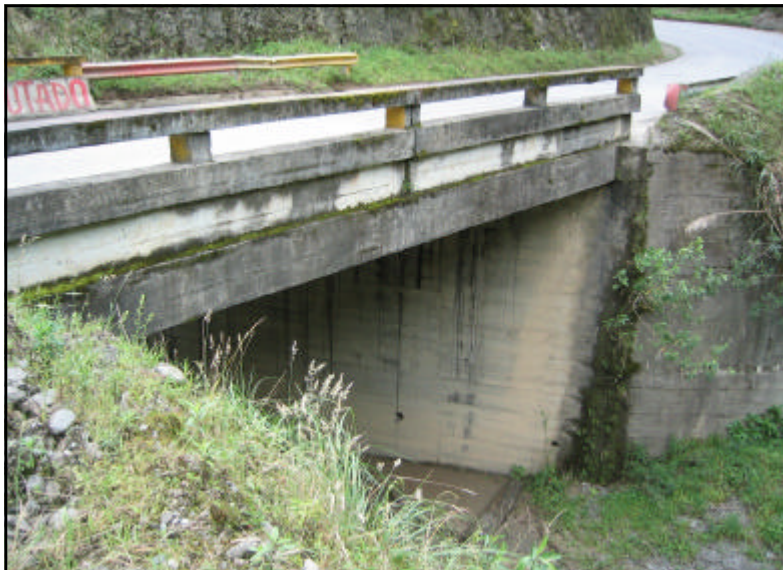
Picture Title: BR33.jpg

Similar to BR21.

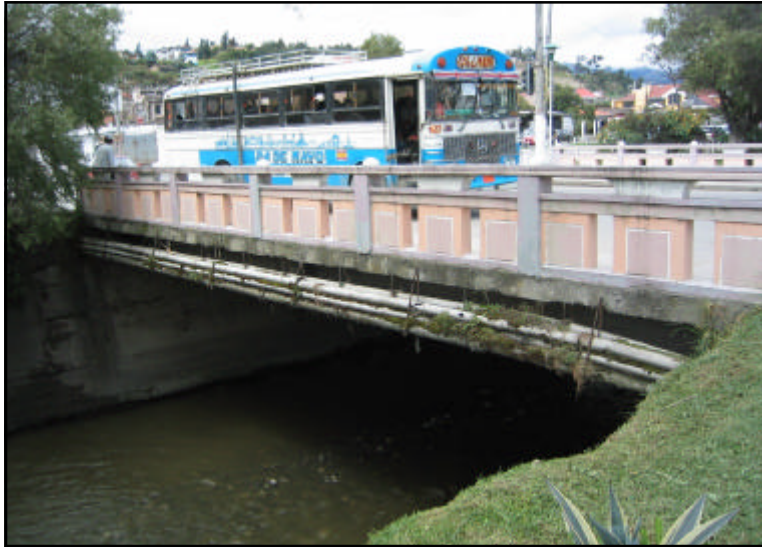
Picture Title: BR34.jpg

While this bridge is in Loja and while in good shape it is unlikely to be used rather than BR35.

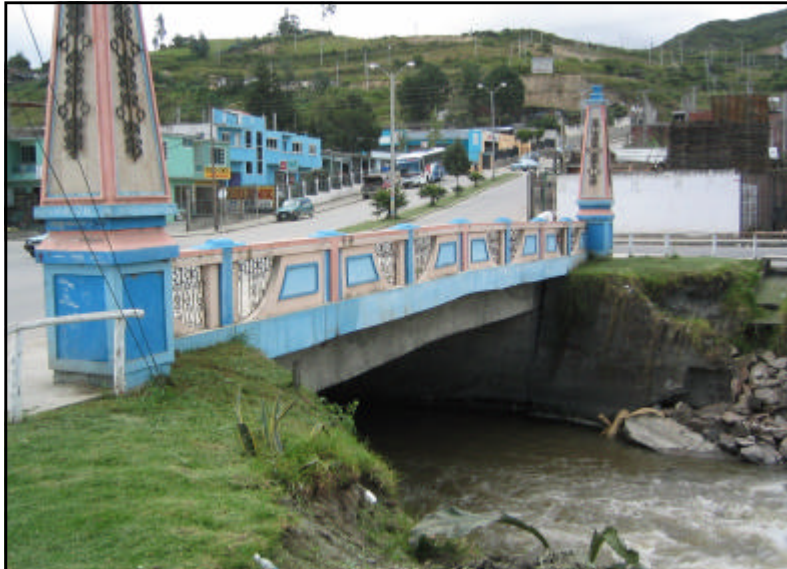
Picture Title: BR35.jpg

Good construction concrete bridge in Loja, full width and well used.

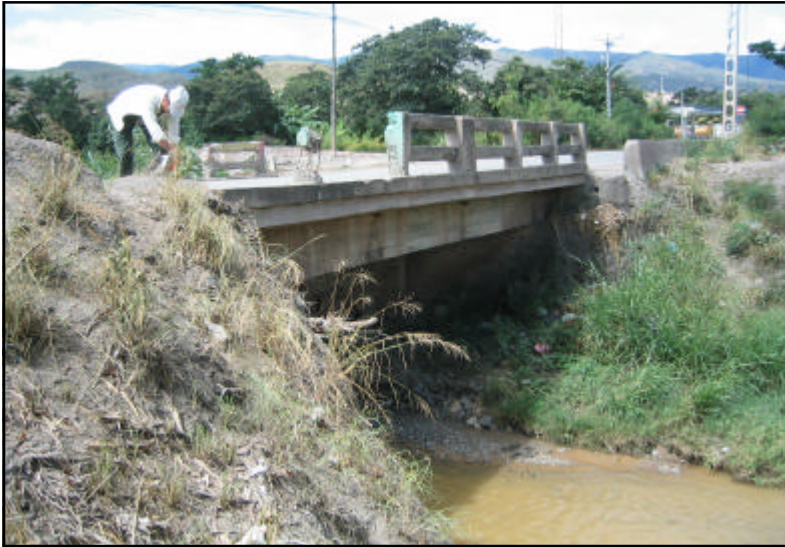
Picture Title: BR36.jpg

Bridge on the route through Catamayo - similar to BR21 with some remediation work to be done on the guard rail. The road that would be used would be around the town starting at this point.

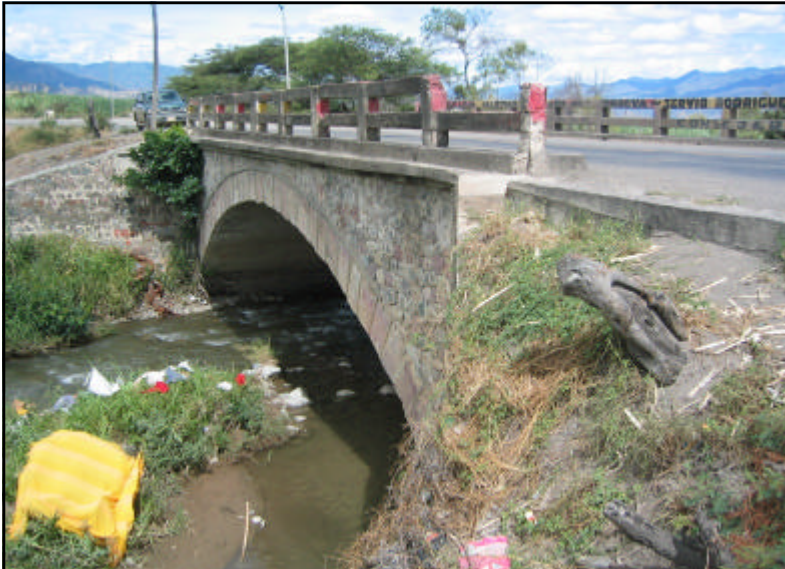
Picture Title: BR37.jpg

Good quality arch bridge, full width.

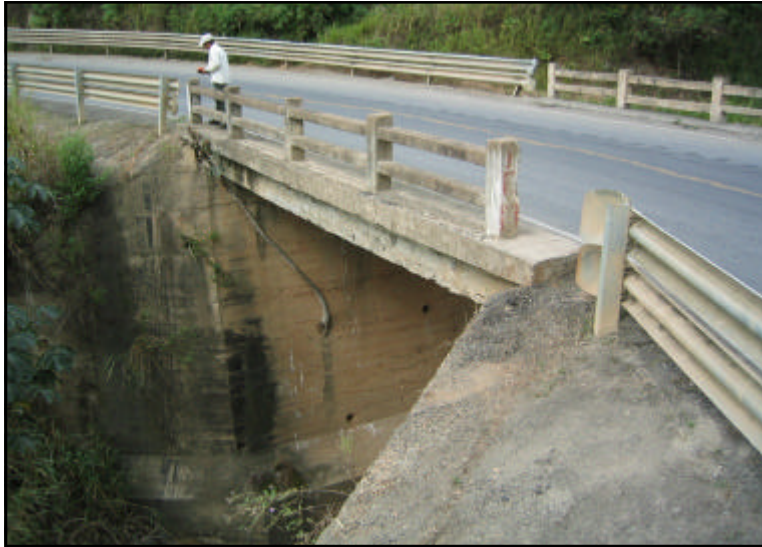
Picture Title: BR38.jpg

Some 40kms further to the west of the previous bridge. Similar to BR21 with full travel width.

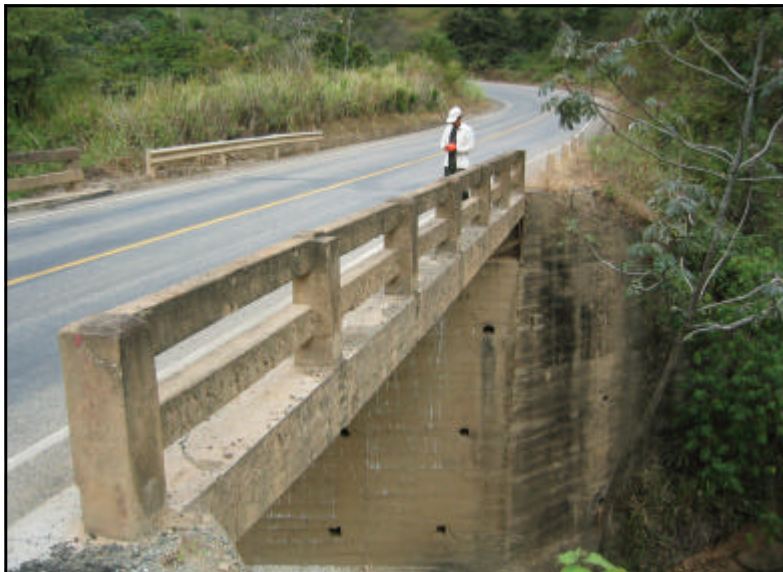
Picture Title: BR39.jpg

About 10 m long and similar to BR21.

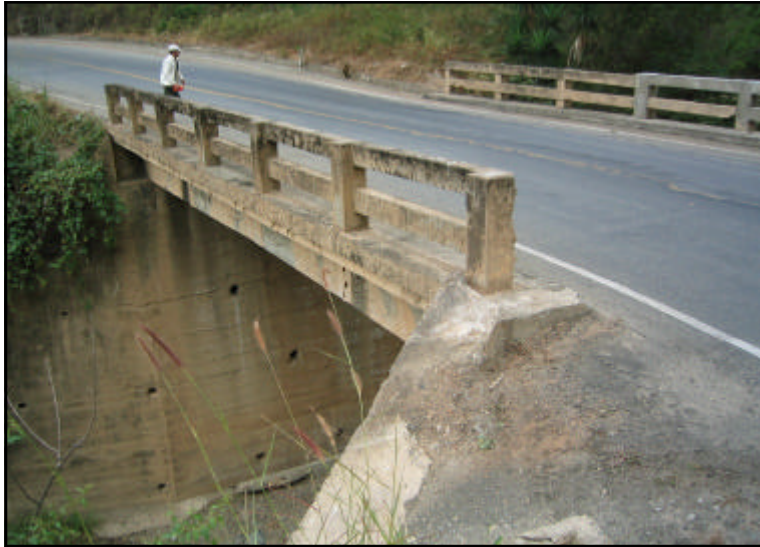
Picture Title: BR40.jpg

Similar to BR21.

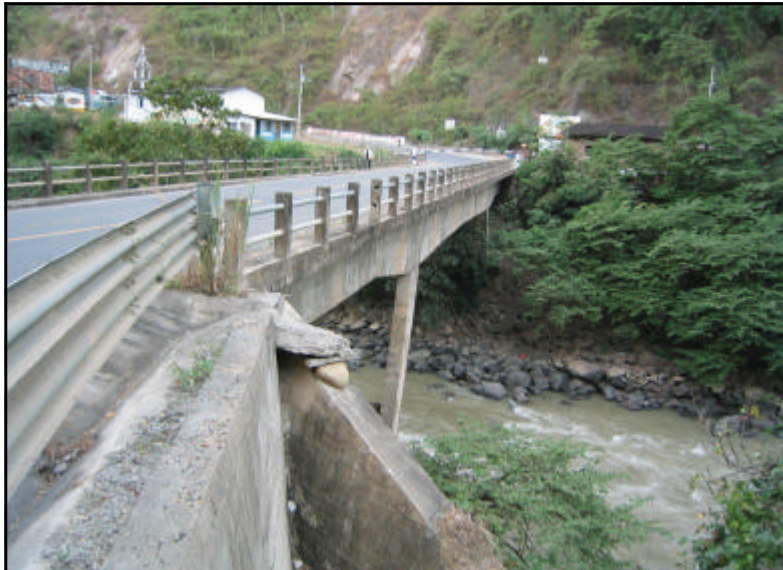
Picture Title: BR41.jpg

While the approaches are tight in both directions, we saw two heavily loaded transport trucks easily negotiate the road. Some additional structural review will need to be made of the centre support, but generally this 60m long bridge appears to be adequate.

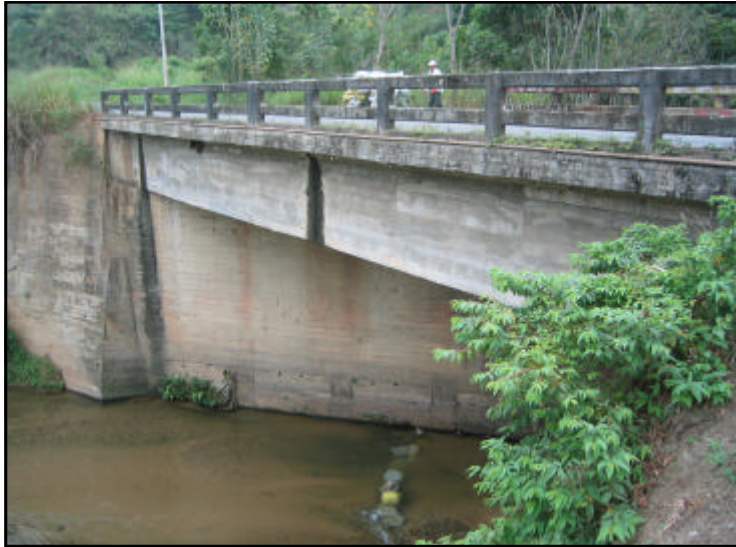
Picture Title: BR42.jpg

Similar to BR21.

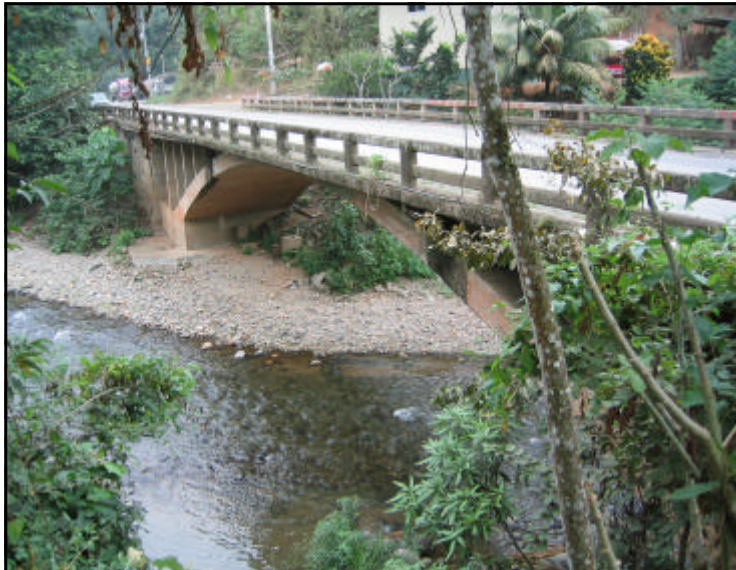
Picture Title: BR43.jpg

Good construction concrete arch bridge with full travel width.

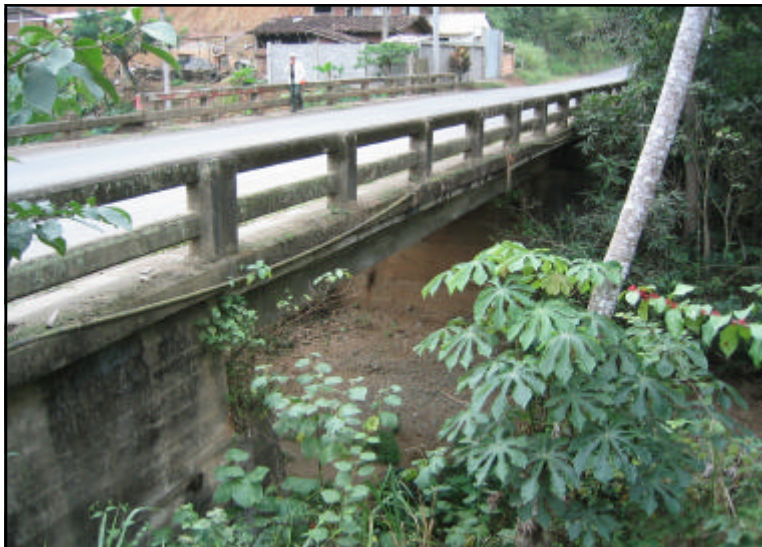
Picture Title: BR44.jpg

Very close to previous bridge, and similar to BR21 but about 20m long.

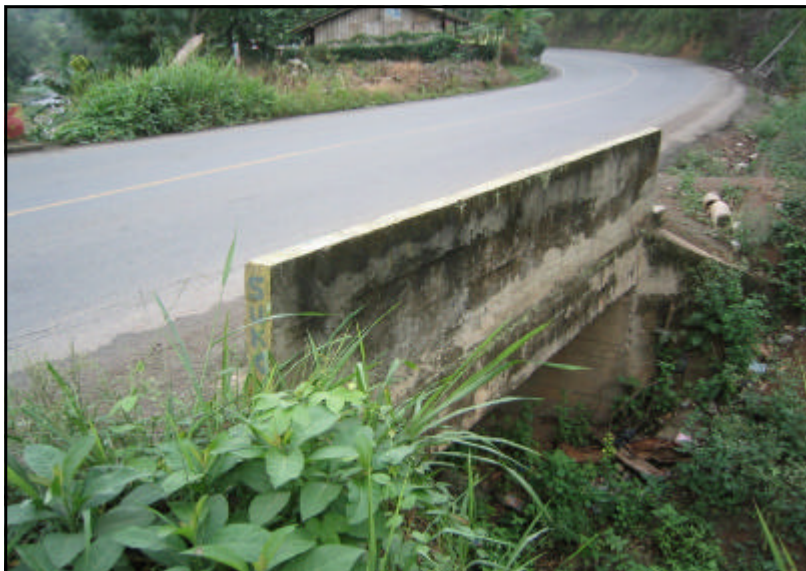
Picture Title: BR45.jpg

Similar to BR21.

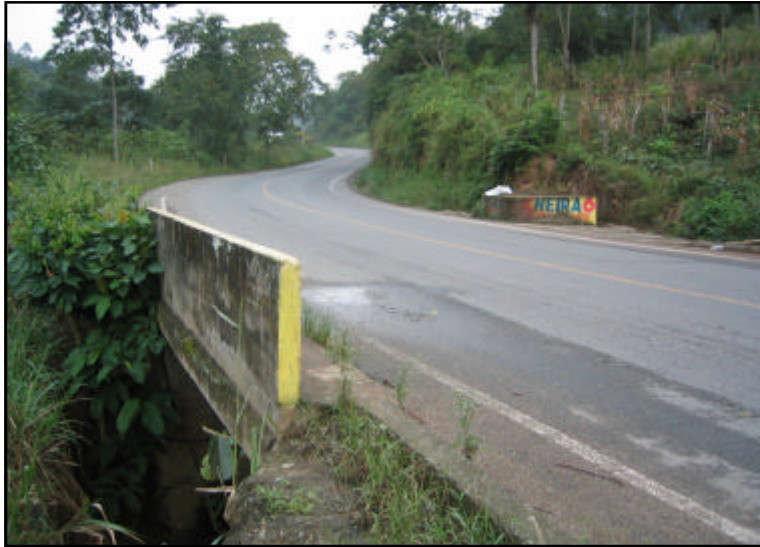
Picture Title: BR46.jpg

Similar to BR21.

There will be a need to find a better route around the town of Piedras before reaching this bridge. The town is well populated and the main access through is strewn with overhead electrical wires and people crossing with markets on both sides.

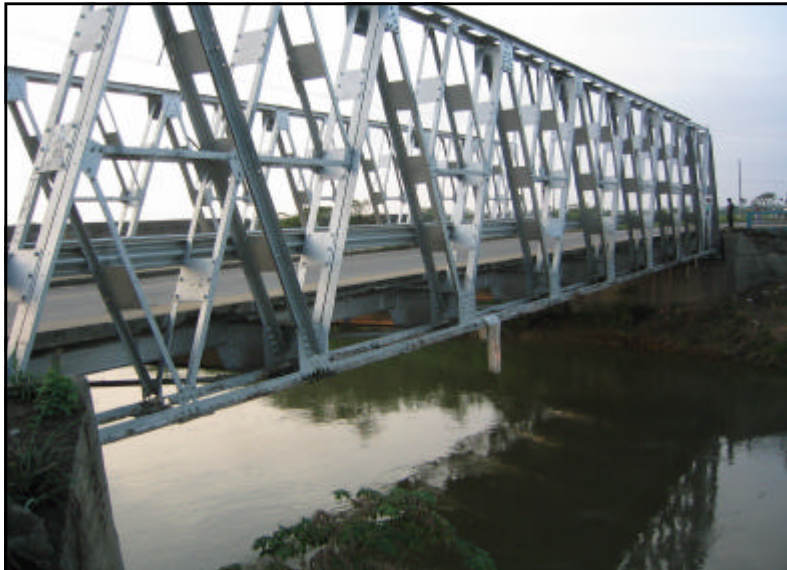
Picture Title: BR47.jpg

Bailey style bridge in good condition on the west side of Santa Rosa.

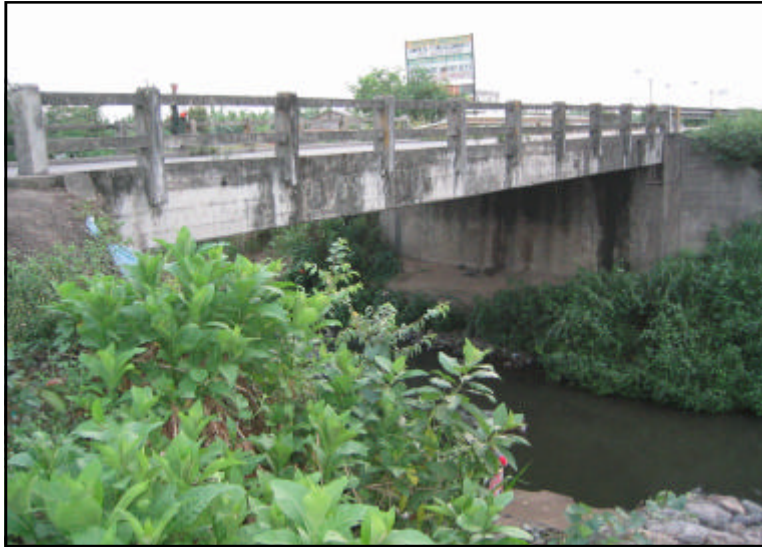
Picture Title: BR48.jpg

Last bridge on the route before meeting at Machala. Similar to BR21.

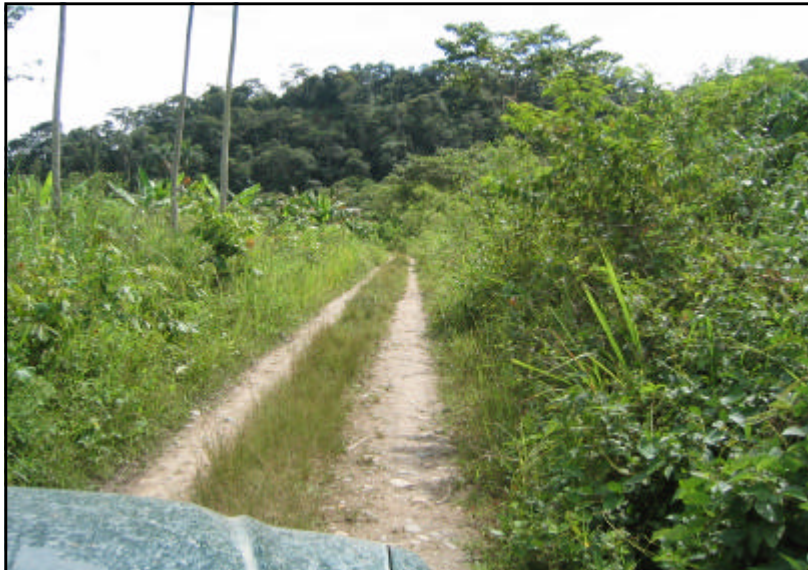
Picture Title: Road_to_ZomoraNarrows.jpg

Shows the gravel road from the site to the Zamora River that needs widening.
